Partial immersion study

Corrosion studies on **GeoBrom® HG520**

BROMINATED DERIVATIVE PRODUCTS FOR MERCURY CONTROL

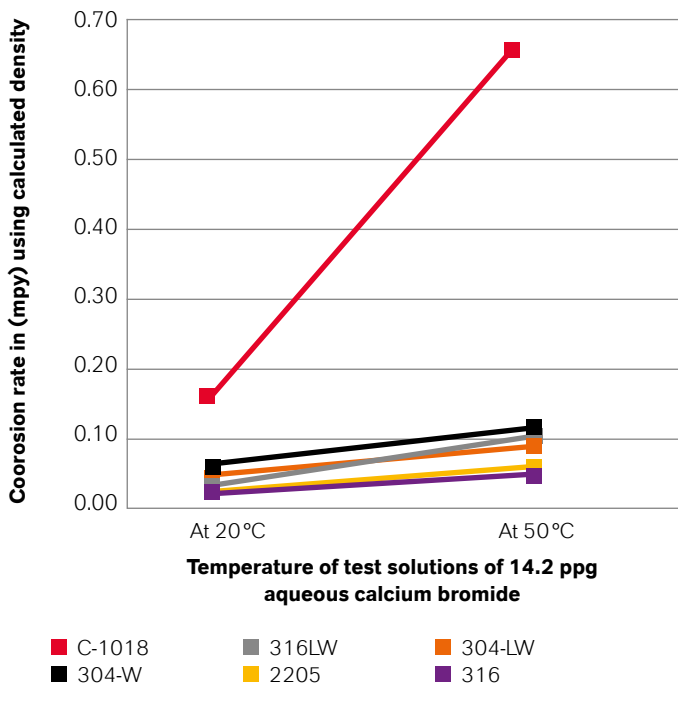
Figure 1: Corrosion rate trend chart with Y axis at 0 to 1.4 mpy scale

Corrosion coupons at 20°C and 50°C subsurface in GeoBrom® HG520 calcium bromide solution

Tables 1 and 2 provide data on test specimens at 20°C and at 50°C, respectively. Corrosion rates on all specimens were under 0.70 mpy rate. Mild carbon steel C-1018 gave the highest corrosion rate at 0.14 mpy at 20°C and 0.65 mpy at 50°C. Observations were recorded on the number of pits for each coupon specimen within these tables. Visually, there was no increase in corrosion at the liquid / vapor interface on any of the specimens tested. Corrosion rates for each specimen were charted to reflect trends over the two temperatures 20°C and 50°C and data presented within Figure 1. Table 3 presents the chemical composition of each test specimen.

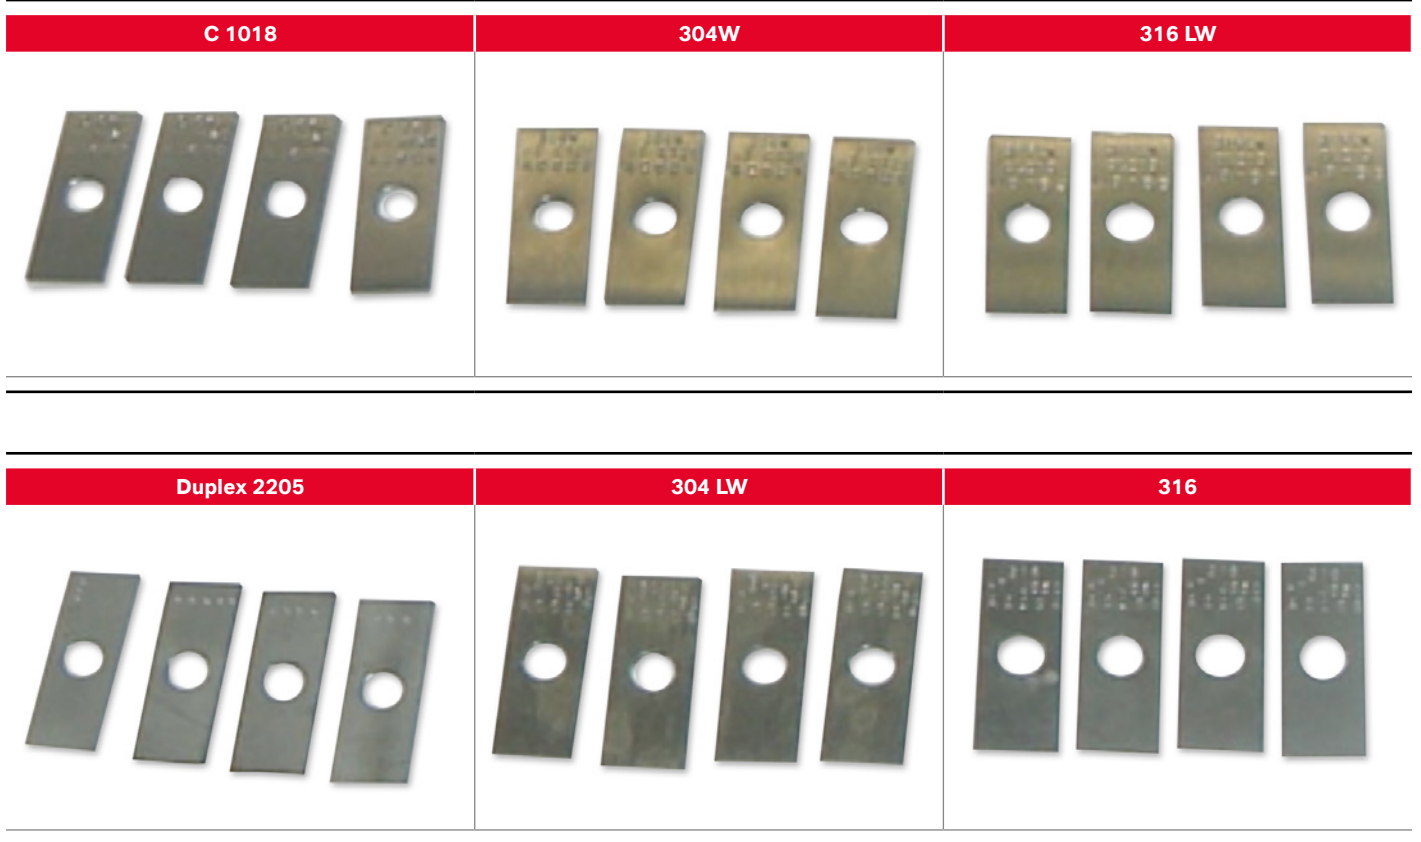
Figure 2: Test coupons before 90-day half above and half below surface exposure

To visually document condition of test specimens, pictures were taken before immersion tests, after, and after cleaning (see figures 2-15). Pitting occurred on stainless coupons where the rusty colored stains formed, which became noticeable after cleaning.

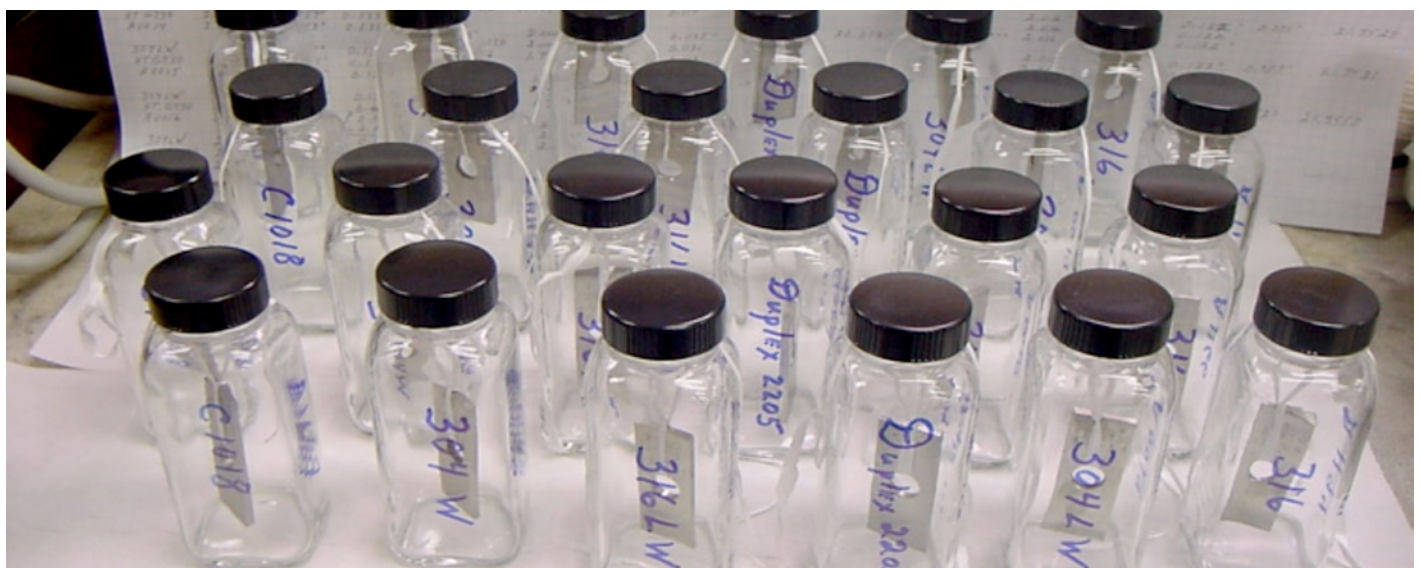
Figure 3: Test coupons before GeoBrom HG520 charged and before 90-day exposure

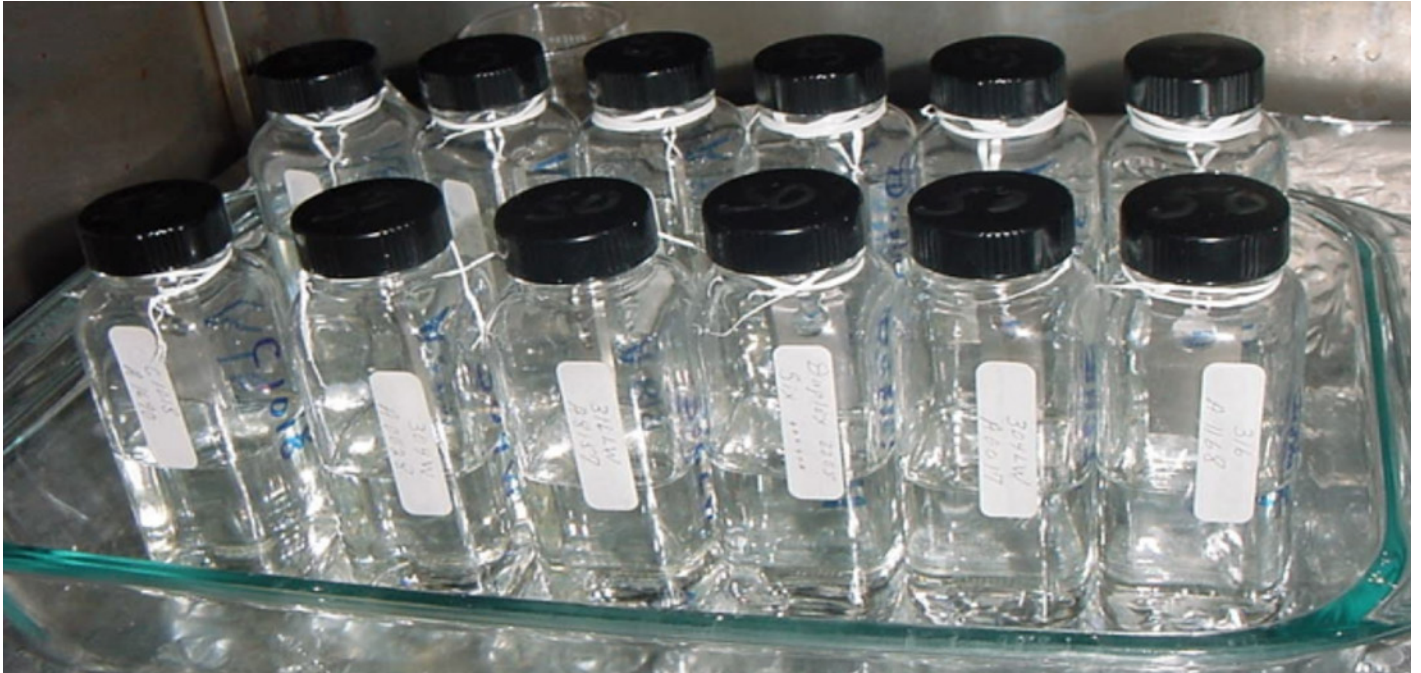
Figure 4: Test coupons before 90-day exposure at above and half below surface in GeoBrom® HG520

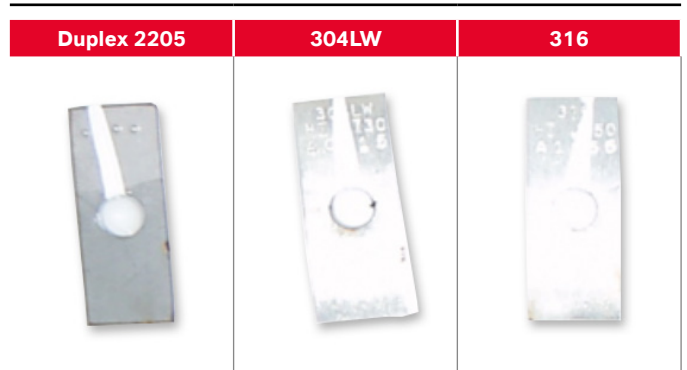
Figure 8: Test coupons before cleaning after 90-day exposure at 20 °C in GeoBrom® HG 520

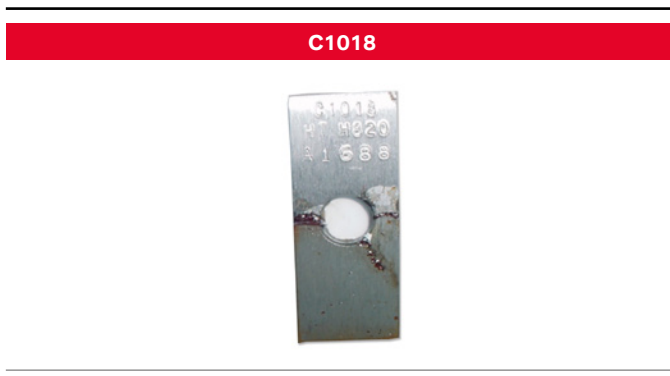
Figure 9: C 1018 coupon at half subsurface before cleaning after 90-day exposure at 20 °C

C-1018 showed signs of a slight surface corrosion in this test and a low corrosion rate. There are a number of different corrosion standards depending on the application. Therefore, whether C-1018 is suitable for use with CaBr₂ depends on the application. These data are relevant only to the 52% CaBr₂ solution. Dilute solutions or other uses of 52% solution may exhibit different corrosive behaviors.

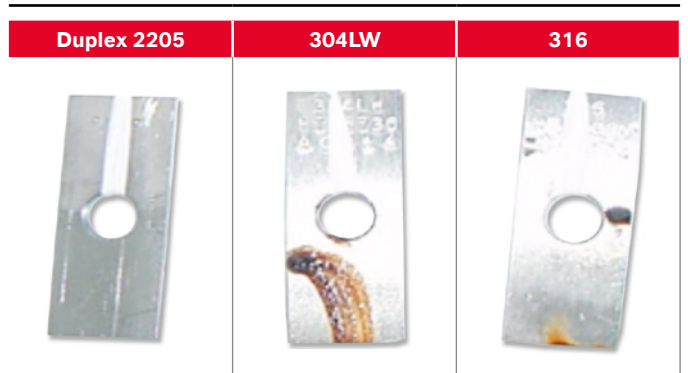
Figure 14: Test coupons half above and half below GeoBrom® HG520 after 90-day exposure at 50 °C before cleaning
